# **PLAINTIFFS' SUMMARY JUDGMENT OPPOSITION**

## **EXHIBIT A-21**

RE: Purported Notice with Respect to Termination of the Ludington Pumped Storage Plant EPC Contract dated October 15, 2010, as amended (the "Contract")

1. Structure of DRE
2. Requirements for DRE
3. Current DRE Situation
  - 3.1 Inspection Acceptance Criteria During Operation
  - 3.2 Condition of Each DRE (PT indications)
  - 3.3 Corrosion situation by Unit
  - 3.4 Cause
    - 3.4.1 DRE NDE PT Indications
    - 3.4.2 Corrosion of Unit 2 and Unit 4 legacy parking ledges
4. Toshiba Proposal
  - 4.1 Toshiba's proposal
  - 4.2 Unit2 and Unit4 Legacy Parking Ledge Repair Procedure

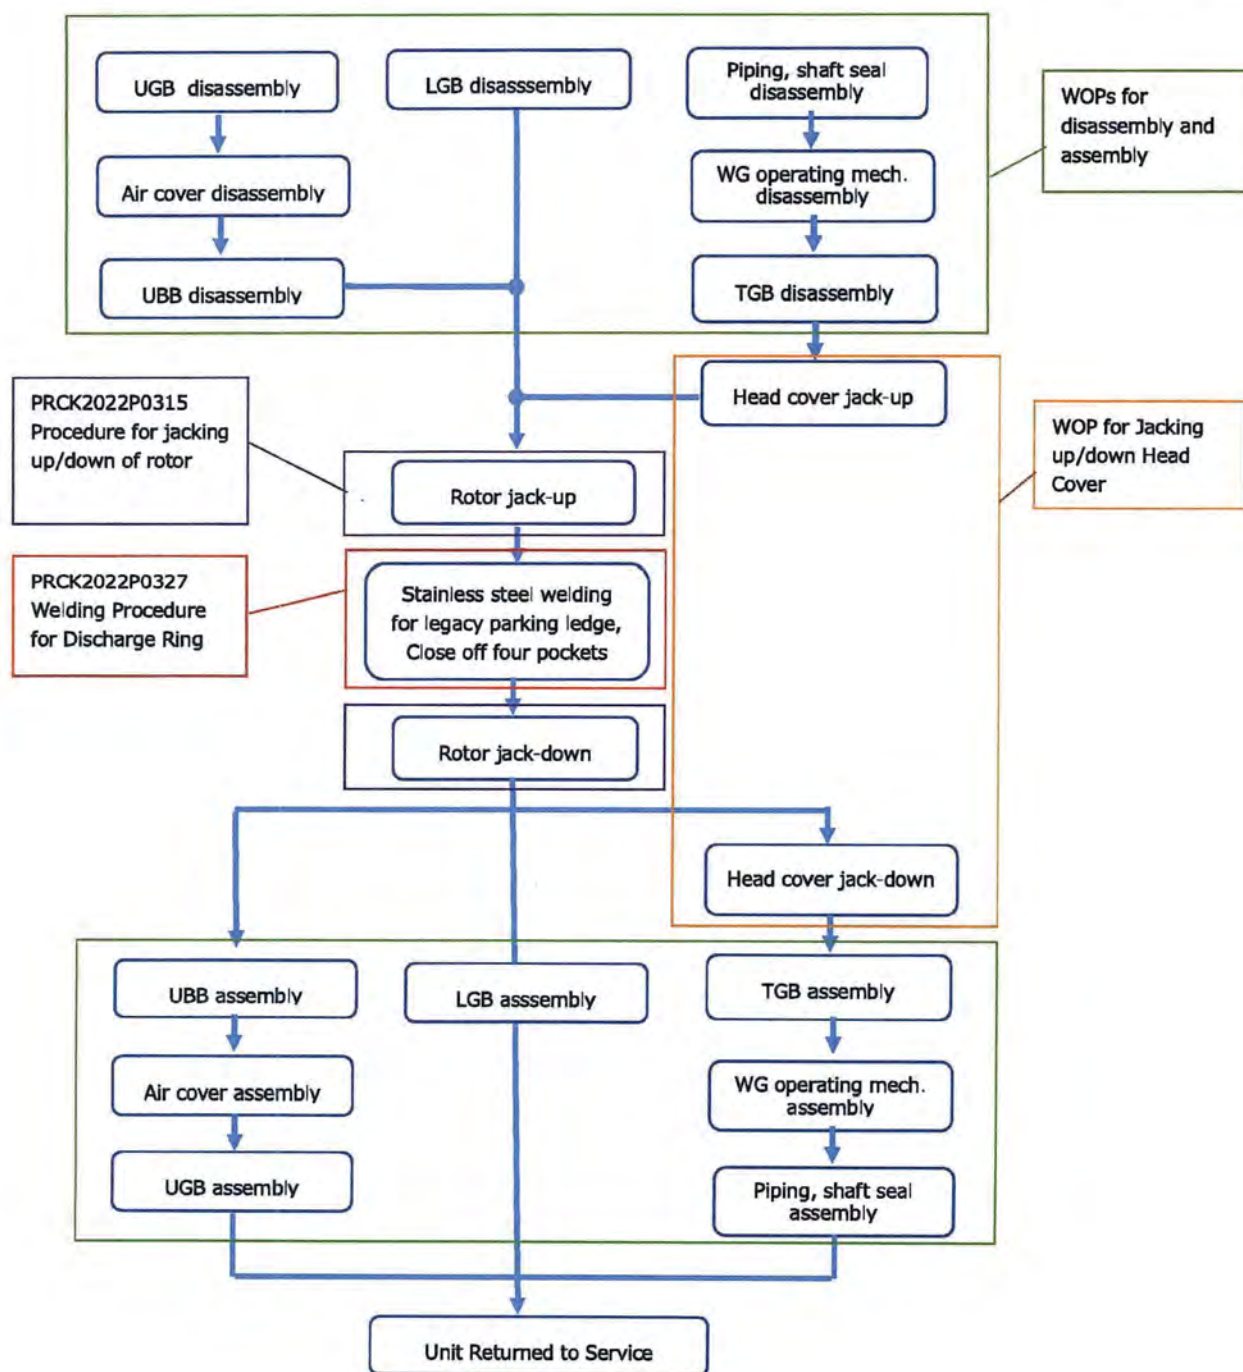
Figure 4.1 Repair Work Flow

Figure 4.1 shows the repair work flow for repair of corroded area of Unit 2 and Unit 4 legacy parking ledges.

A conceptual diagram of repair is shown in Figure 4.2. Disassembly, repair, and re-assembly work steps include:

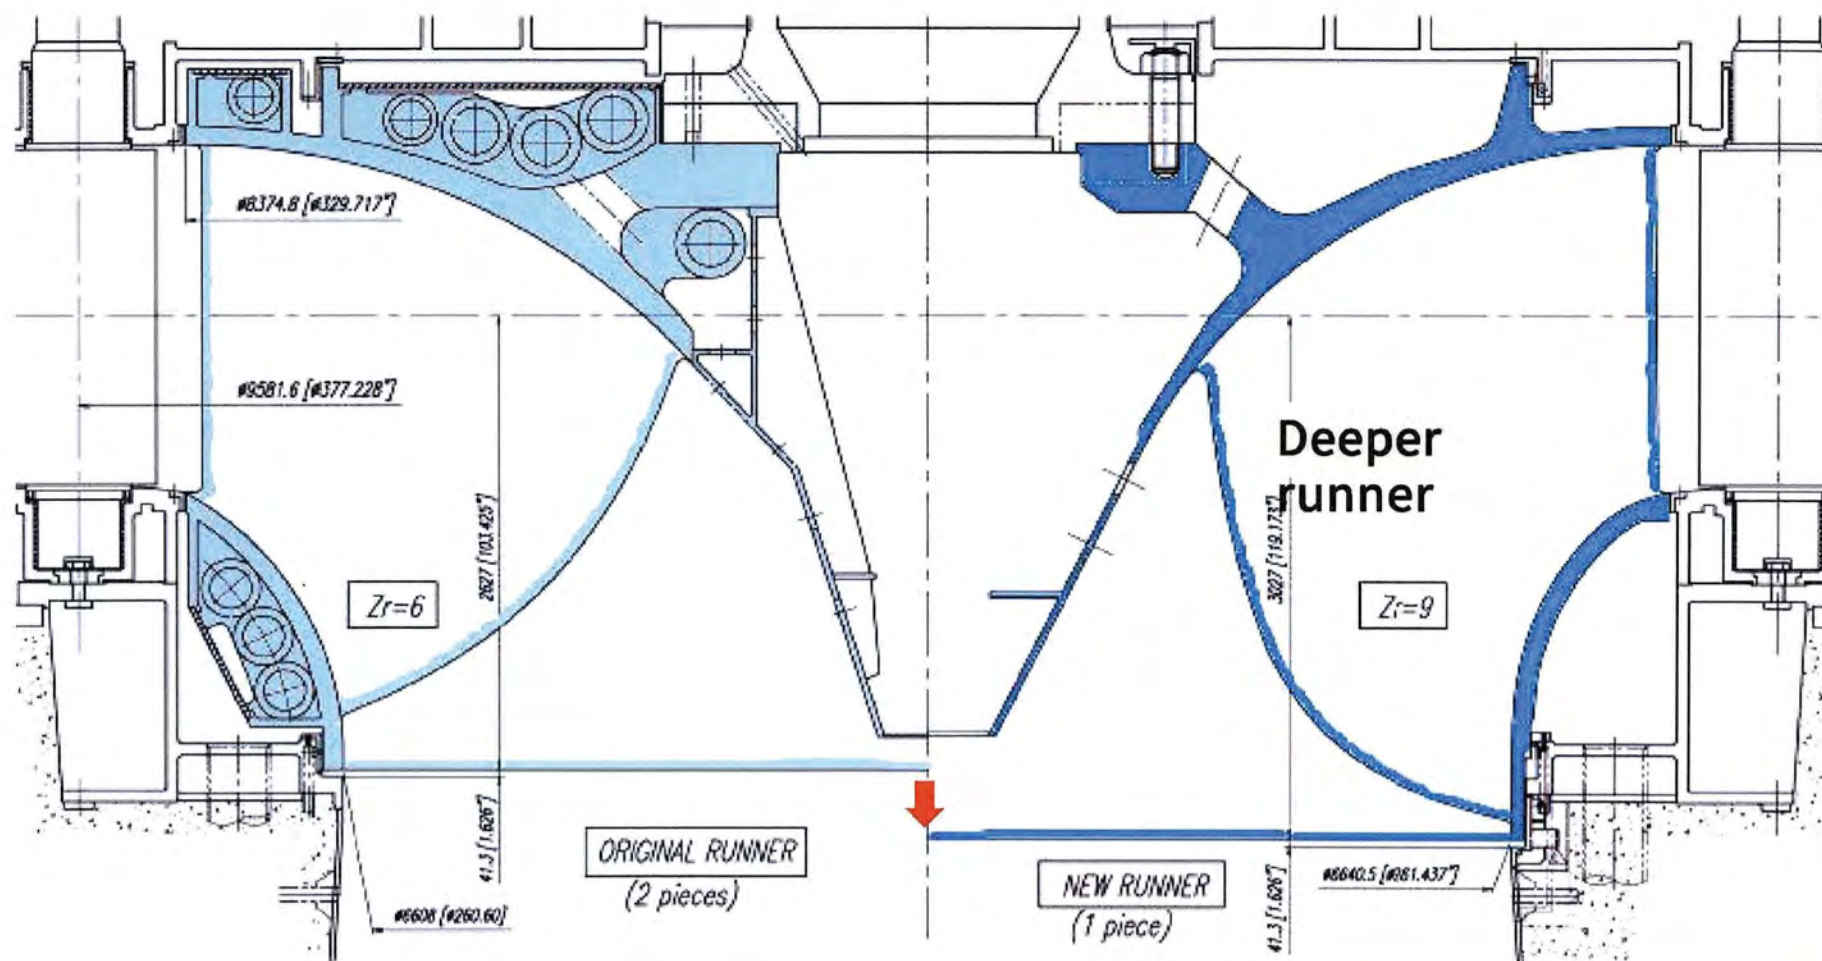
The Original runner had cavitation.

Extended runner vane downstream to improve cavitation performance.

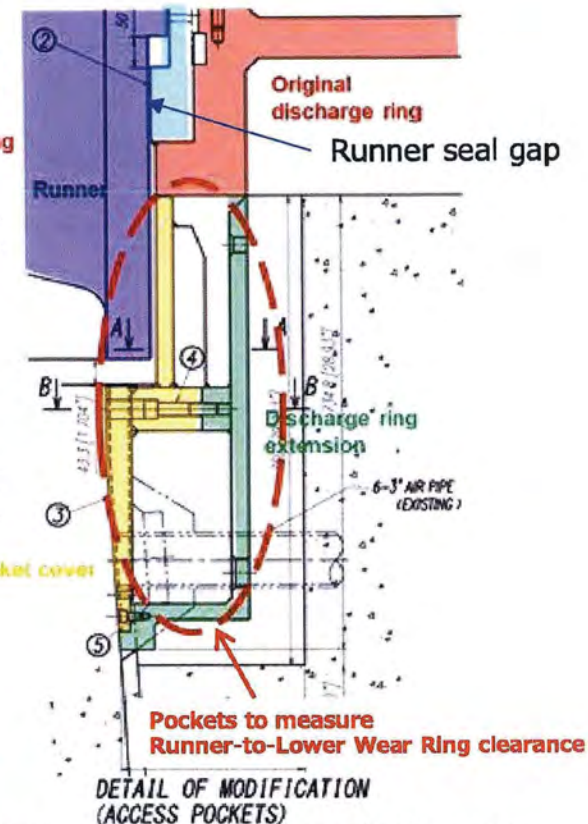
Cross section of pocket area

- 4 pockets for runner seal gap measurement.
- The pocket cover has been dropped in the past and is currently being removed and operated.

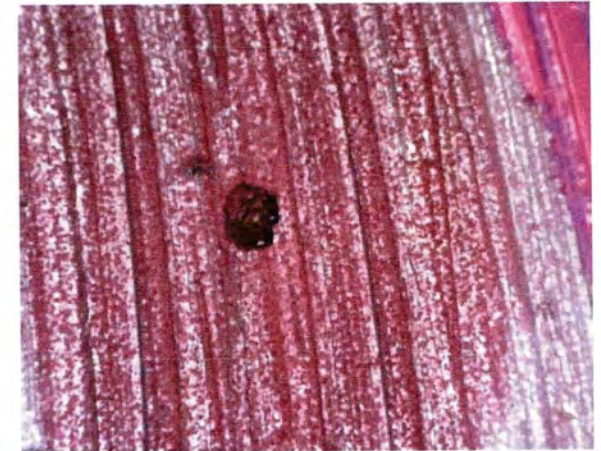
Item ID Number	Location	Feet around	Type	Size	Evaluation	Outage	Remarks
3A	*	2.80	Rounded	3/8"	REJECT	2022	Lower Vertical Plate

Rounded indication

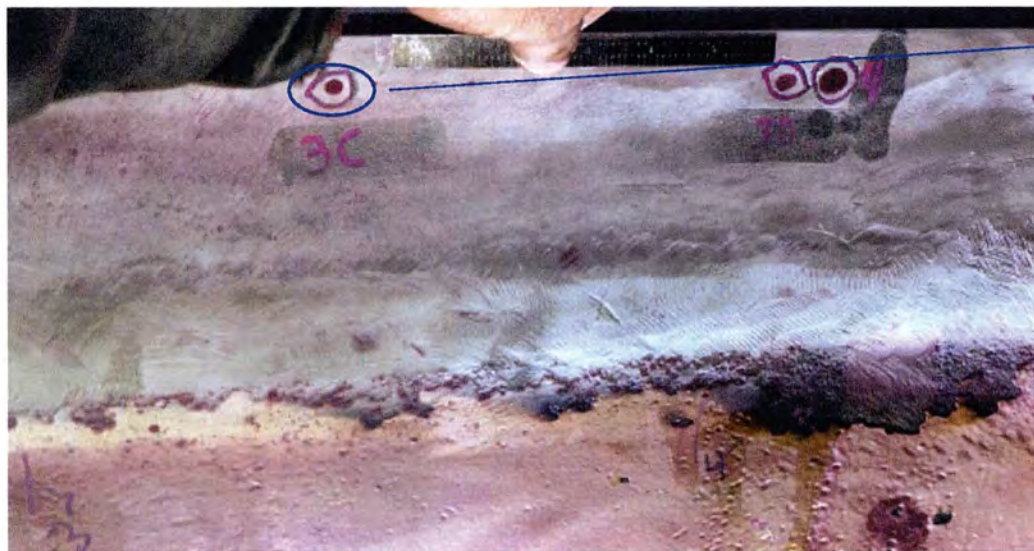
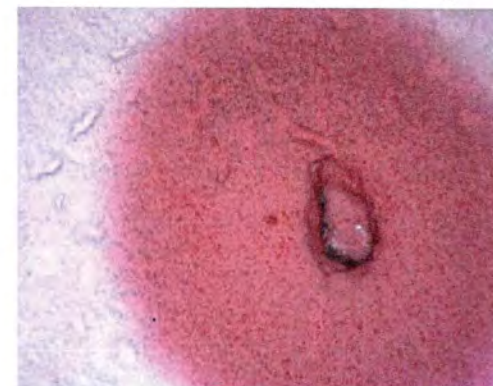
Item ID Number	Location	Feet around	Type	Size	Evaluation	Outage	Remarks
3C	*	3.60	Rounded	3/8"	REJECT	2022	Lower Vertical Plate

## Rounded indication

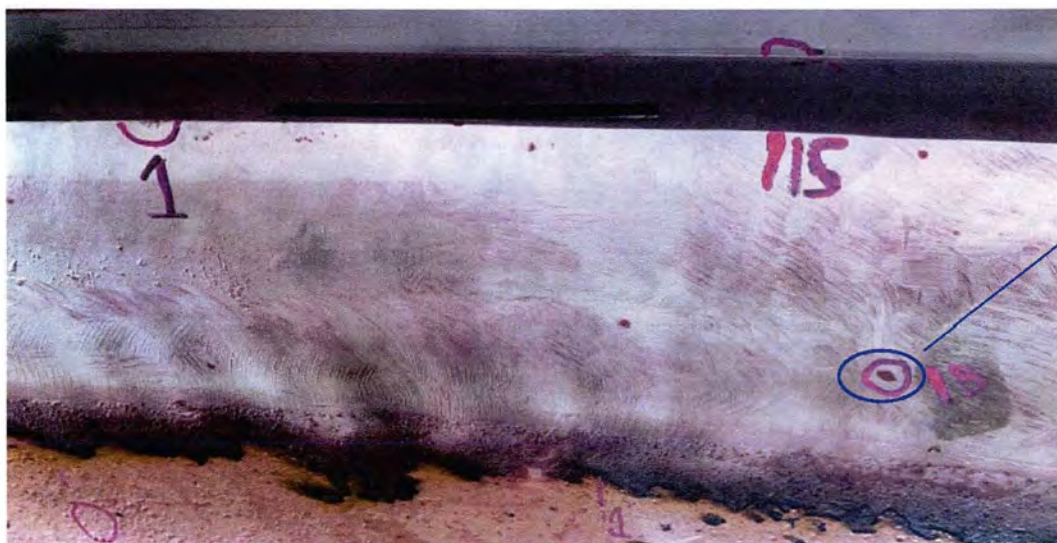
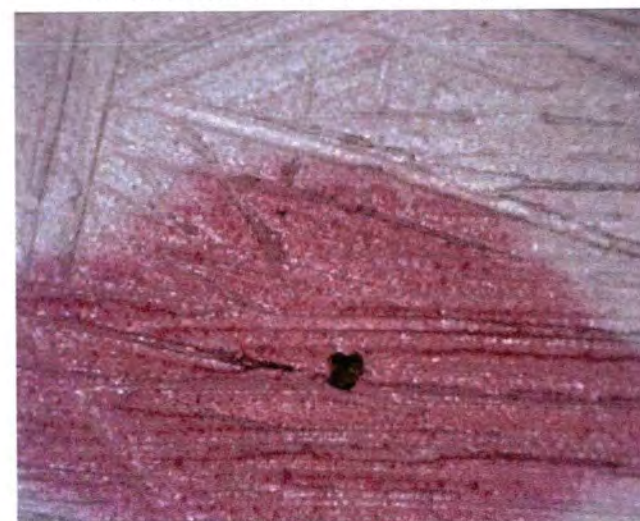
Item ID Number	Location	Feet around	Type	Size	Evaluation	Outage	Remarks
1B	*	1.30	Rounded	3/8"	REJECT	2022	Lower Vertical Plate

**Rounded indication**

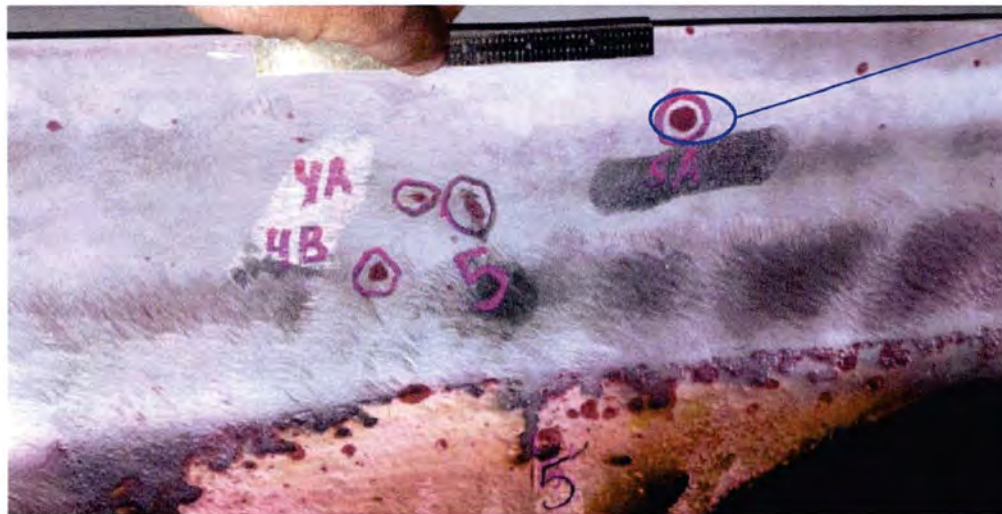
Item ID Number	Location	Feet around	Type	Size	Evaluation	Outage	Remarks
SA	*	5.25	Rounded	5"	REJECT	2022	Lower Vertical Plate

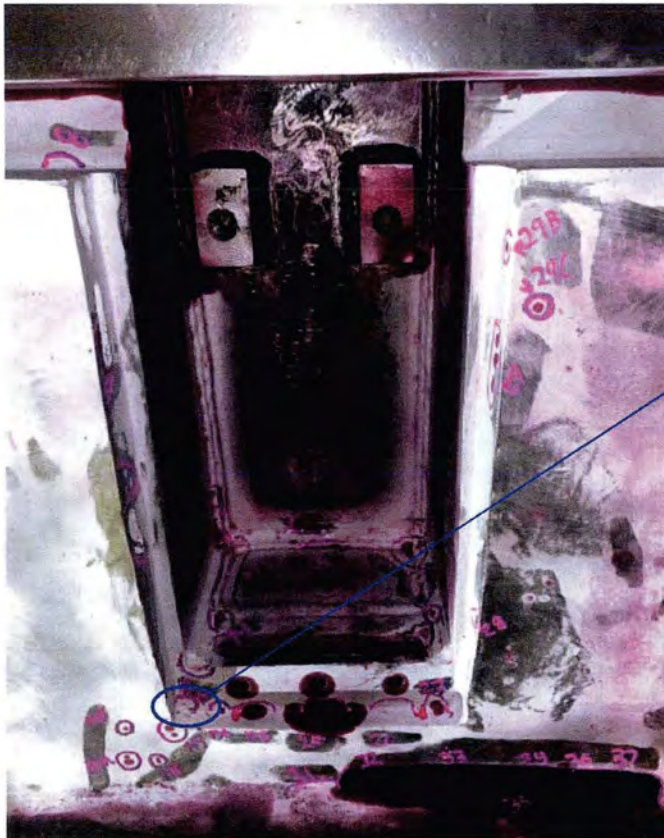
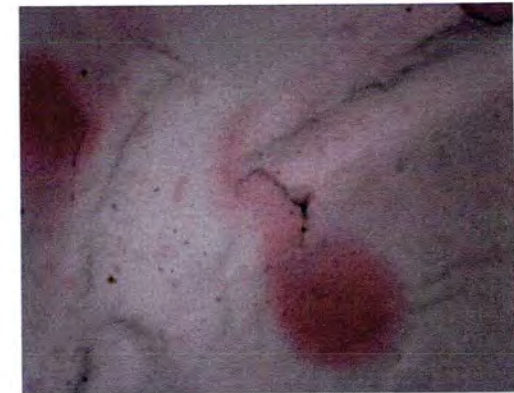
Item ID Number	Location	Feet around	Type	Size	Evaluation	Outage	Remarks
13	*	9.19	Rounded	1/4"	REJECT	2019	Previous rejections. Excavated

Rounded indication  
Insufficient finish of weld bead. Not progressive

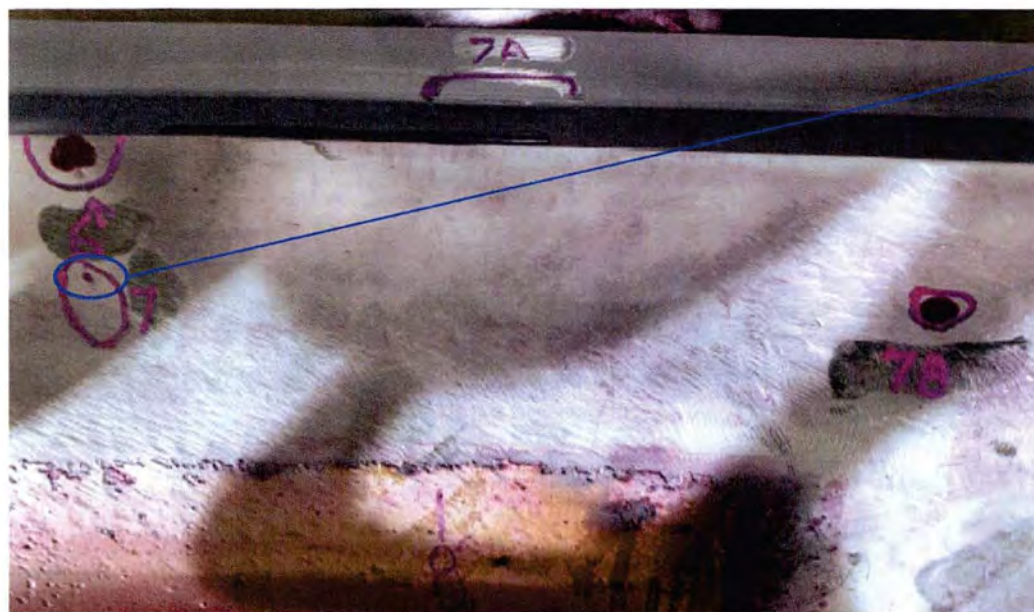
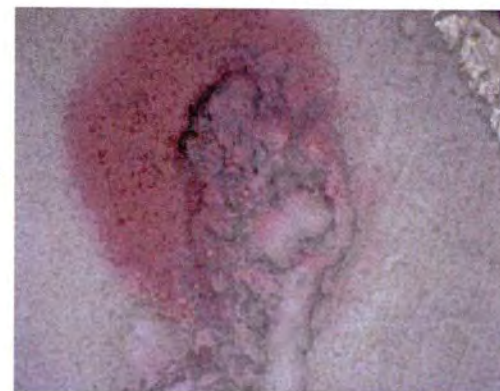
Item ID Number	Location	Feet around	Type	Size	Evaluation	Outage	Remarks
7	*	7.52	Linear	1"	REJECT	2019	Lower Vertical plate.

Linear indication

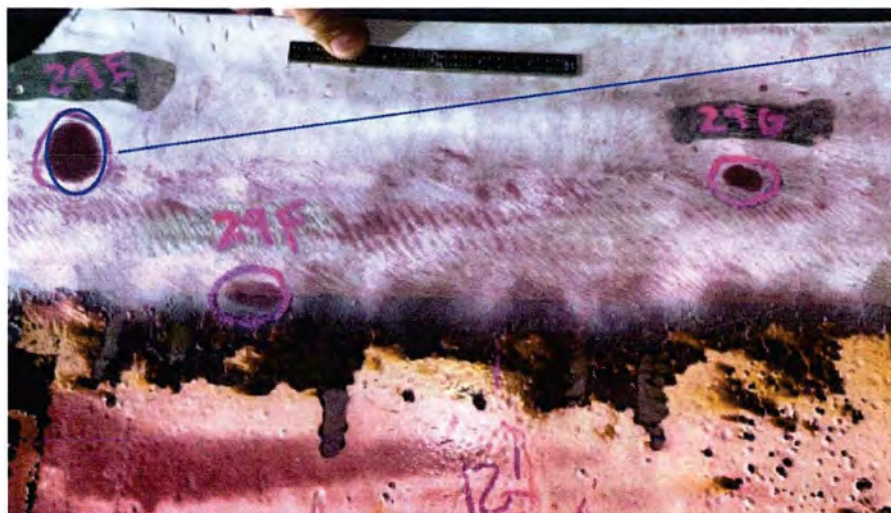
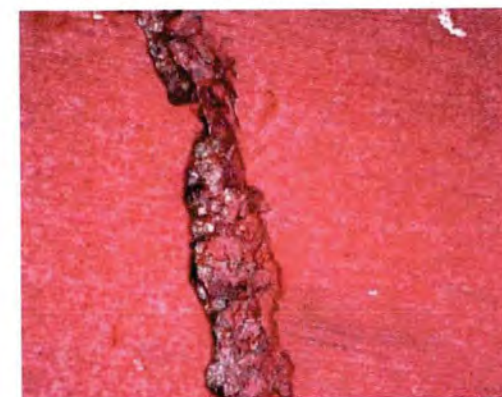
Item ID Number	Location	Feet around	Type	Size	Evaluation	Outage	Remarks
29E	*	11.00	Linear	1/2"	REJECT	2022	Lower vertical plate.

Linear indication

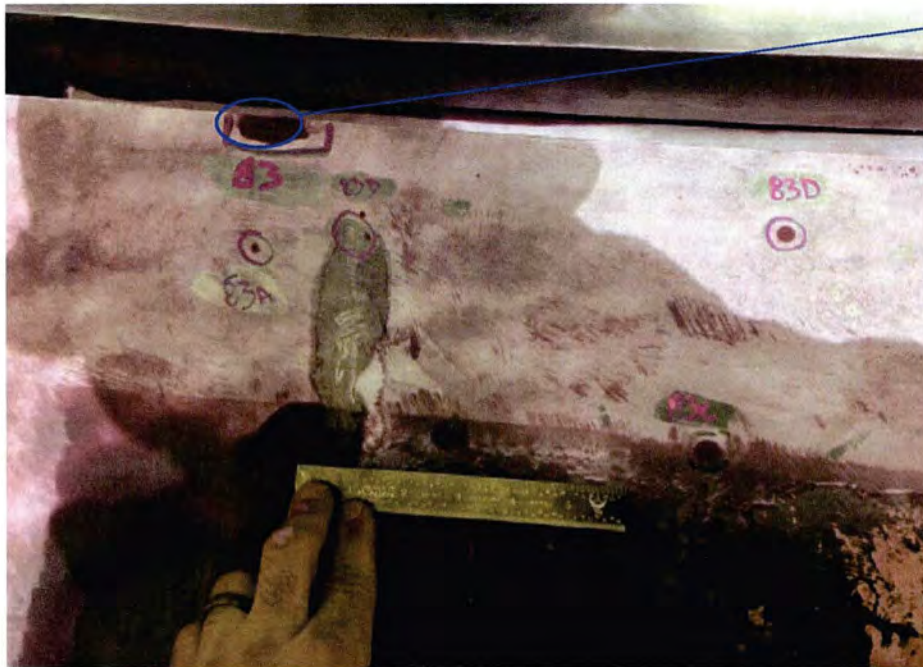
Item ID Number	Location	Feet around	Type	Size	Evaluation	Outage	Remarks
83	*	44.60	Linear	1.25"	REJECT	2019	Lower Vertical Plate

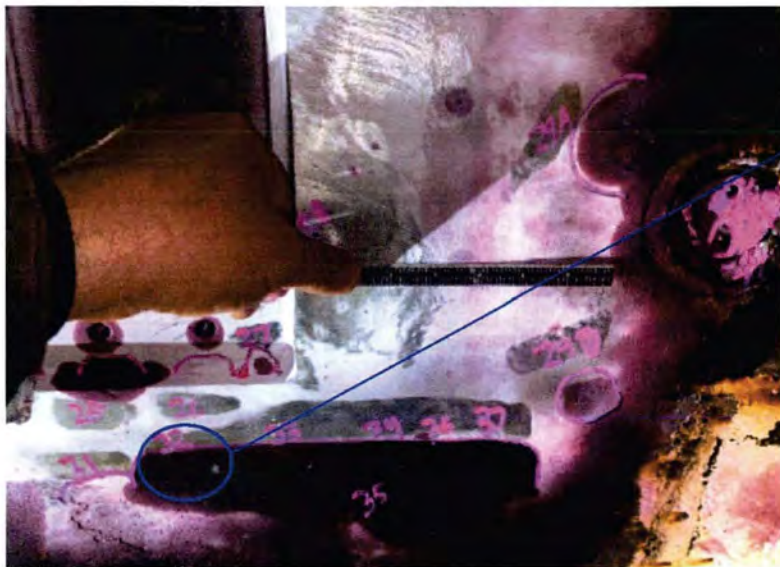
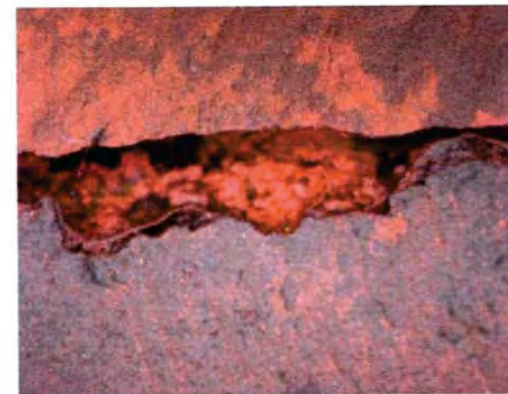
Item ID Number	Location	Feet around	Type	Size	Evaluation	Outage	Remarks
32	*	9.70	Linear	*	REJECT	2019	Previous rejections. Excavated

### Linear indication

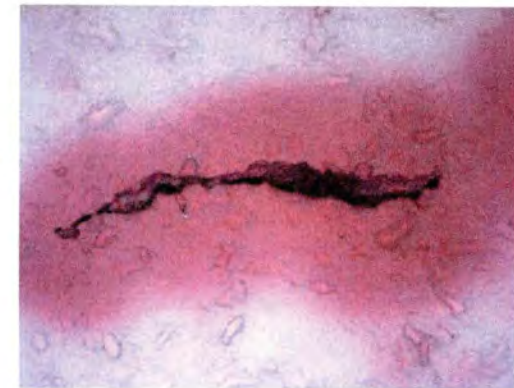
Item ID Number	Location	Feet around	Type	Size	Evaluation	Outage	Remarks
29H	*	13.50	Linear	1/2"	REJECT	2022	Lower vertical plate.

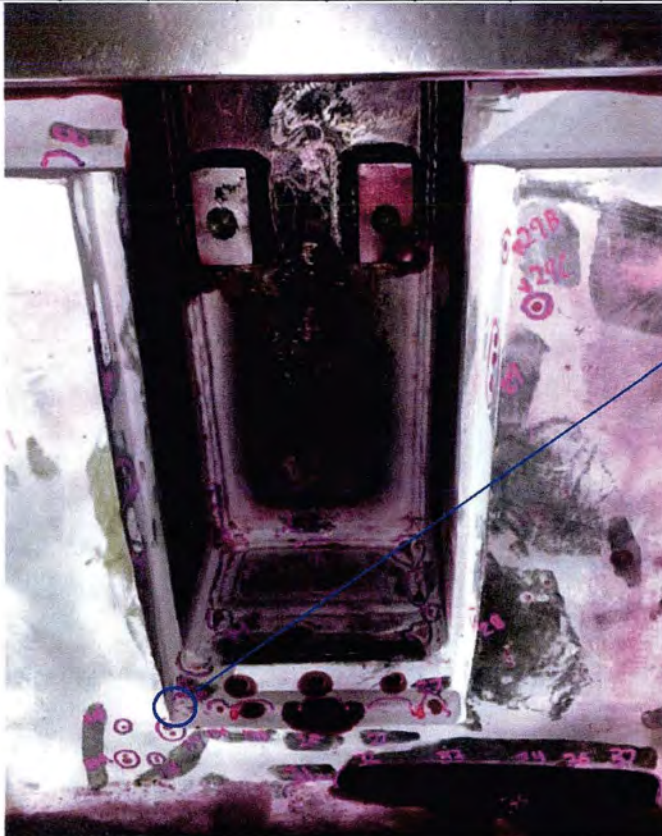
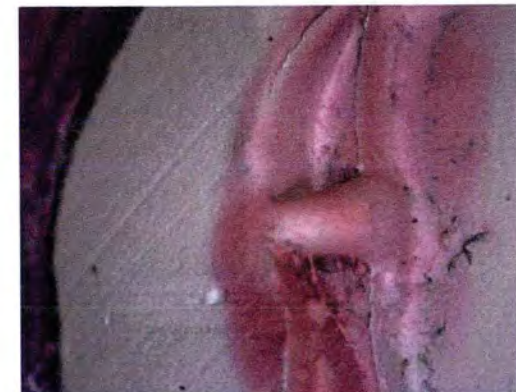
Item ID Number	Location	Feet around	Type	Size	Evaluation	Outage	Remarks
12	*	9.20	Linear	.5"	REJECT	2019	Lower Vertical plate.

Linear indication  
 Insufficient finish of weld bead. Not progressive

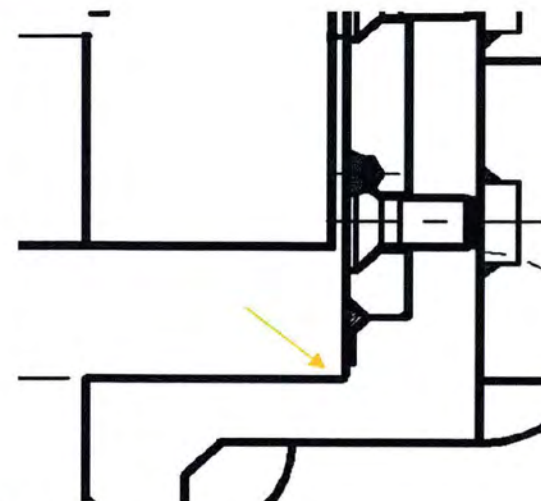
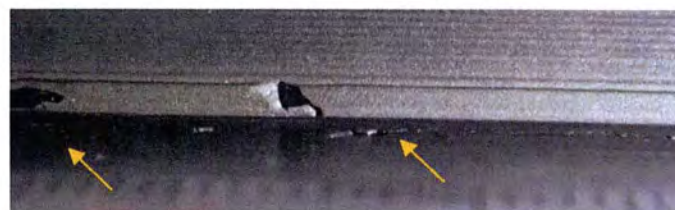
Item ID Number	Indication					Remarks
	Feet	Type	Size	Evaluation	Lo Rule Number	
86 End	63.05	Linear	8" Total	Reject	4	Intermittent indication Parking ledge corner

### Linear indication

Burr at machining surface.

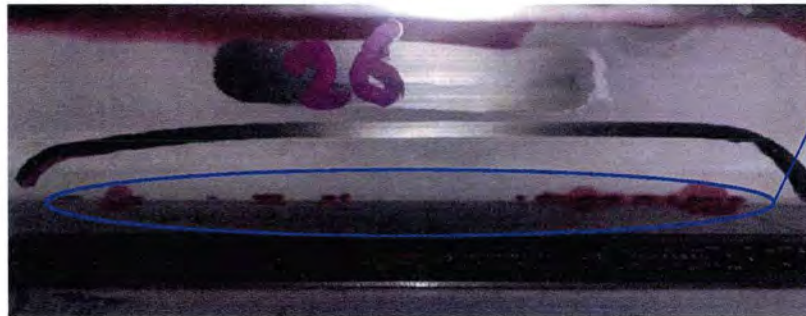
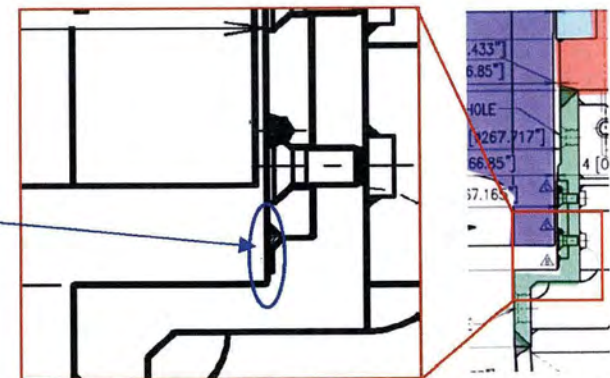
Item ID Number	Indication					Remarks
	Feet	Type	Size	Evaluation	Lo Rule Number	
26	15.68	Linear	5.5"	Reject	4	Intermittent indication Parking ledge corner

Linear indication  
Ummelted portion of the weld  
below the lower seal liner.  
There flaws do not impair the basic  
DRE requirement.  
No need to repair

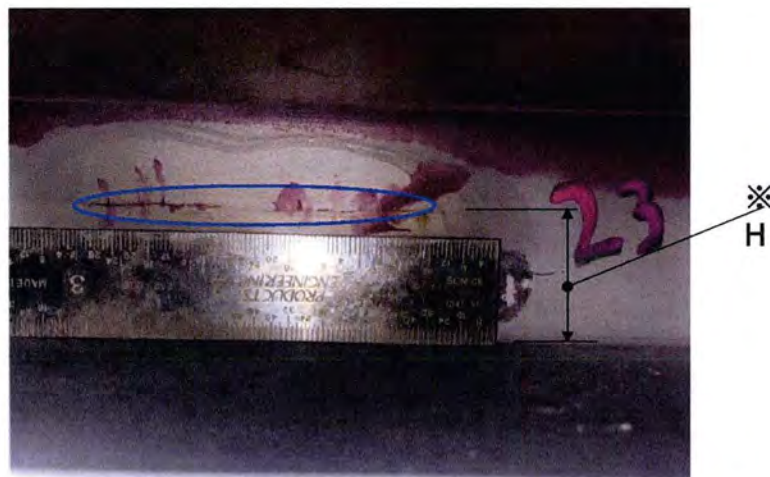
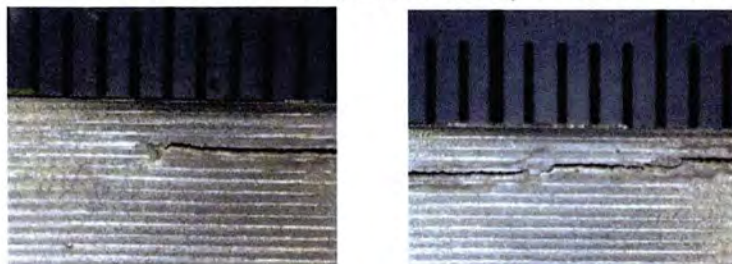
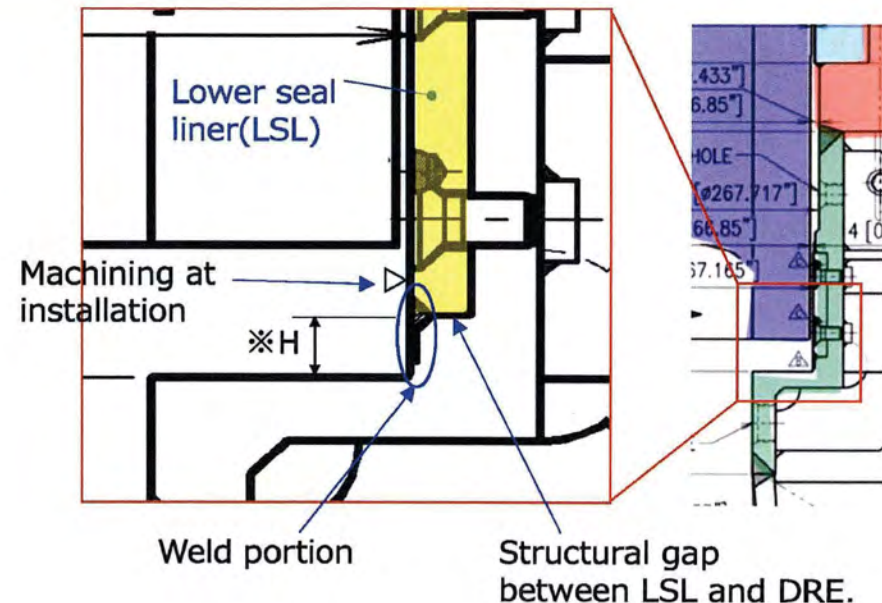
Item ID Number	Indication					Remarks
	Feet	Type	Size	Evaluation	Lo Rule Number	
23	12.99	Linear	7.5"	Reject	4	Upper Vertical Plate/Propagating

Weld portion below LSL was almost removed by machining at installation.

Structural gap between LSL & DRE was exposed due to wear.

No need to repair

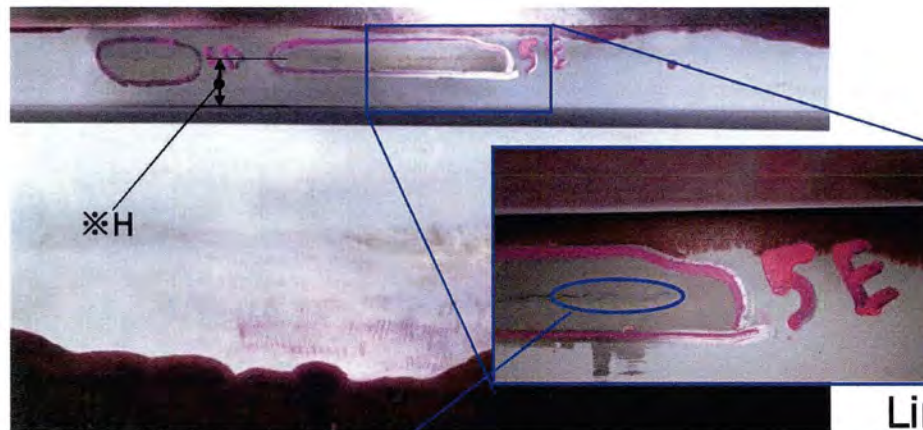
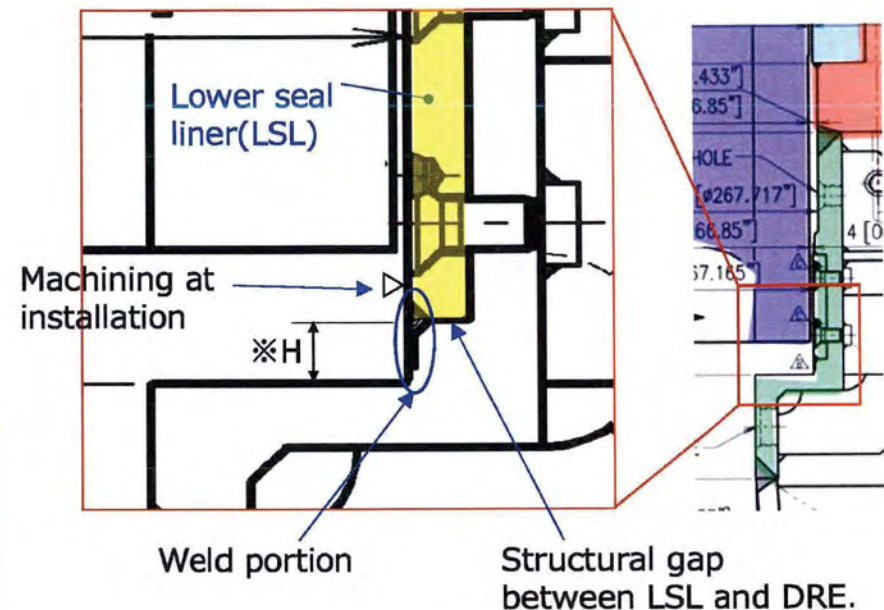
Indication Number	Location			Evaluation	Lo Rule Number	Remarks
	Feet	Type	Size			
5E	15.20	Linear	6"	Reject	4	Upper Vertical Plate Intermittent/propagating

Weld portion below LSL was almost removed by machining at installation.

Structural gap between LSL & DRE was exposed due to wear.

No need to repair

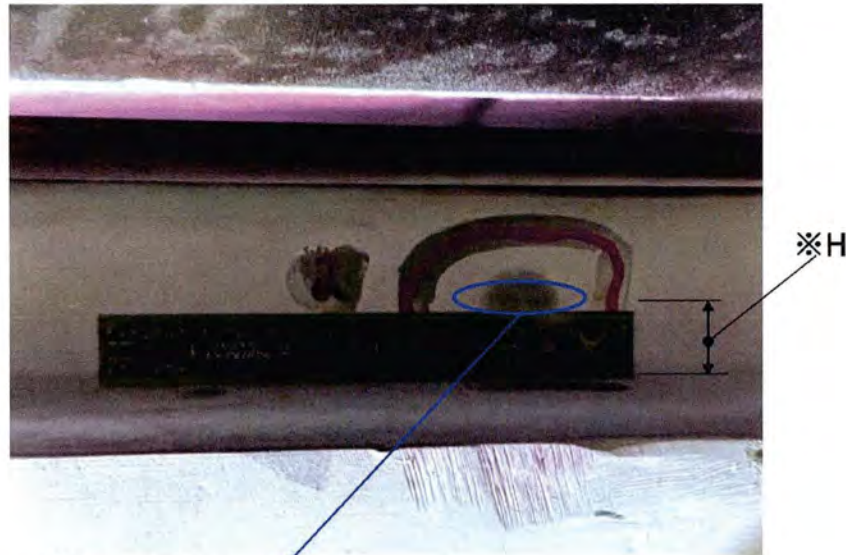
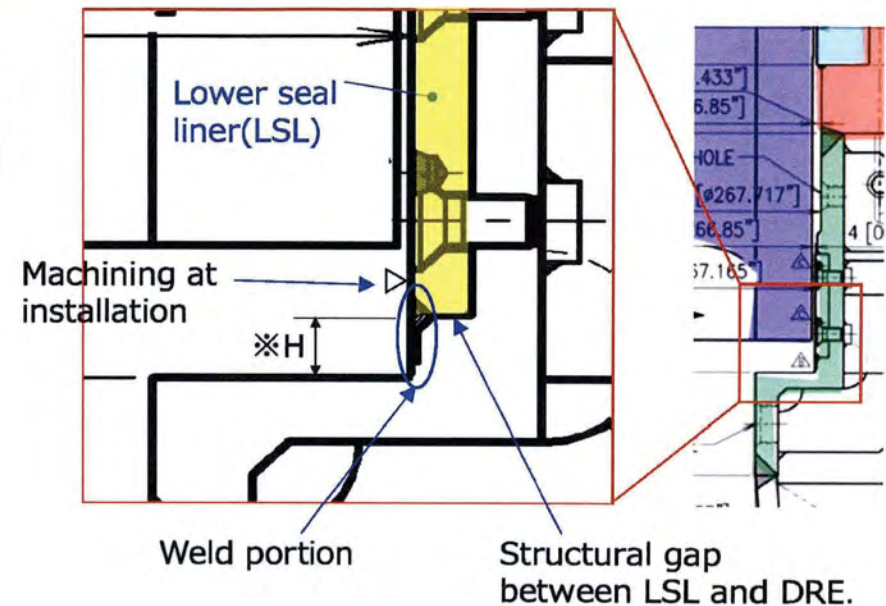
Item ID Number	Welder ID	Indication				Evaluation	Lo Rule No.	Remarks
		No.	Location	Type	Size			
2	N/A	N/A	3.09'	Linear	.500"	Reject	4	Upper Vertical

Weld portion below LSL was almost removed by machining at installation.

Structural gap between LSL & DRE was exposed due to wear.

No need to repair

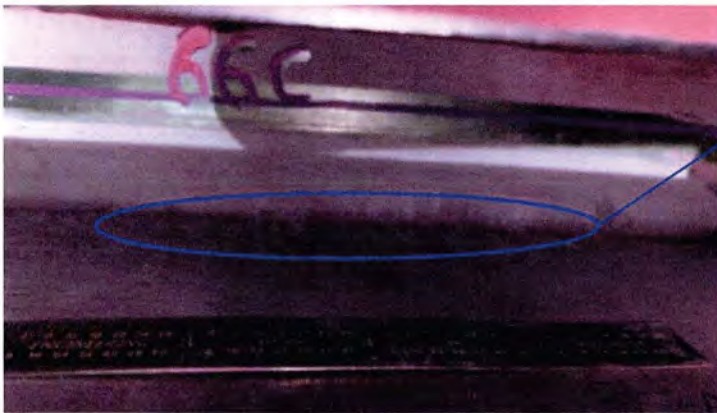
Item ID Number	Location	Feet around	Type	Size	Evaluation	Outage	Remarks
66C	*	38.00	Linear	10"+	REJECT	2022	Parking ledge inner corner.

No obvious defect was found by the observation with microscope.

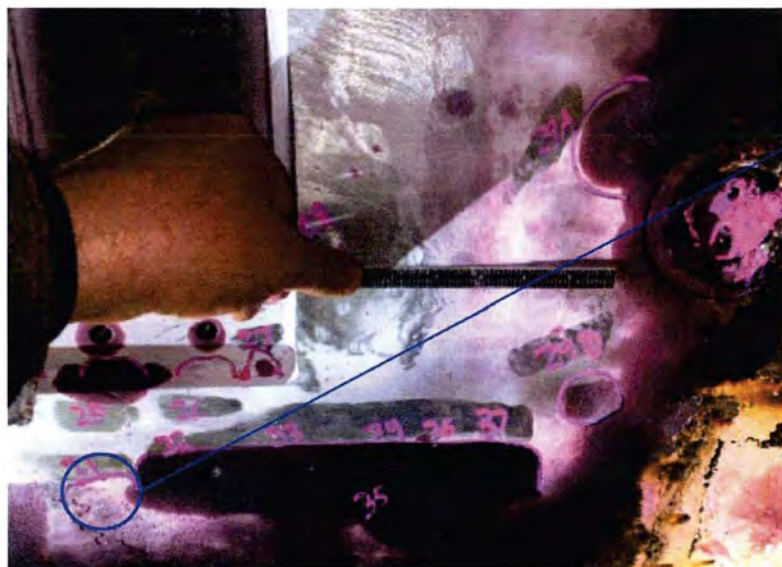
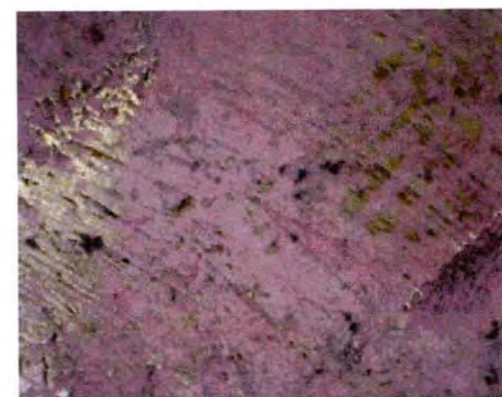
Item ID Number	Location	Feet around	Type	Size	Evaluation	Outage	Remarks
31	*	9.50	Linear	*	REJECT	2019	Lower vertical plate.

No obvious defect was found by the observation with microscope.

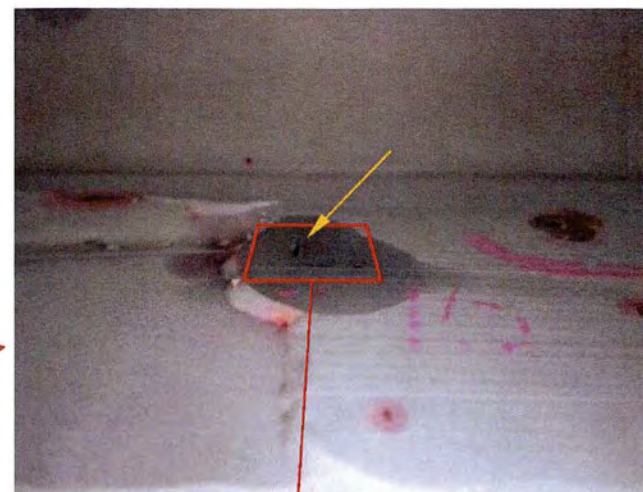
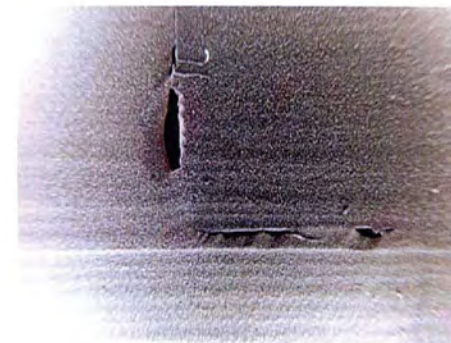
Pocket "SE"

## Unit 5 DRE water bleeding from pocket cover

Most of the fillet welds were removed when machining after installation. Thin weld portion was penetrated due to wear and tear during the operation.

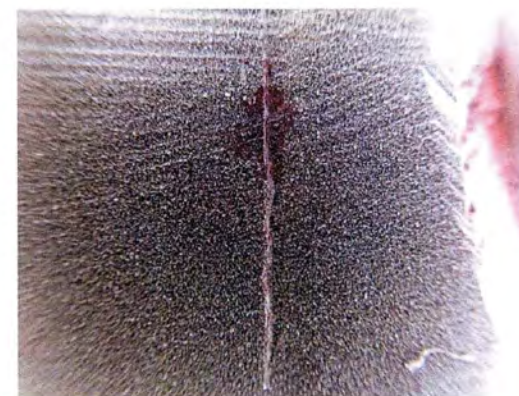
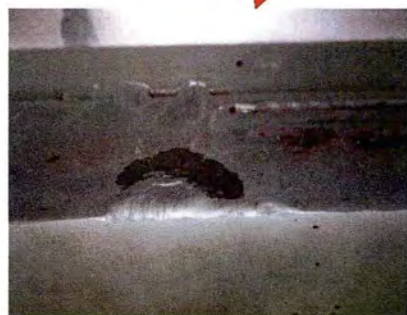
Pocket "SW"

## Unit 5 DRE water bleeding from pocket cover

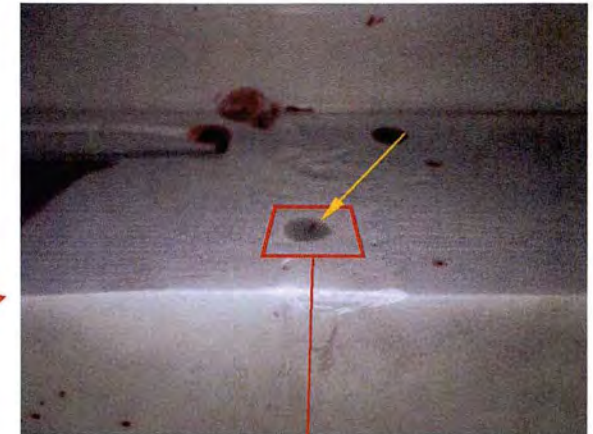
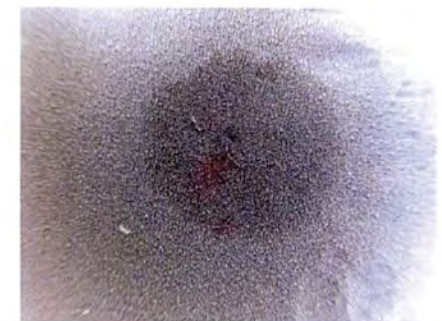
### Pocket "NW"

## Unit 5 DRE water bleeding from pocket cover

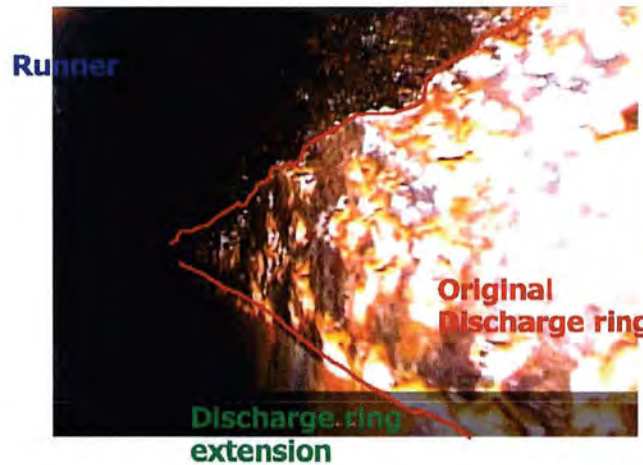
No.76

- The original PL (parking ledge) was divided into 84 blocks with a circumference of 250 mm and the original PL condition was checked.
- In the lower end of the original PL, corrosion was confirmed around 3 of the 4 runner gap inspection windows. The maximum depth exceeds 20 mm.
- No additional paint in 2021 remains on the corroded area.
- The original PL near the wearing ring fillet was corroded not only near the inspection pocket but also at multiple locations.

Location	Lower part of the original PL corrosion depth measurement value (mm)
1	20
61	20
76	15

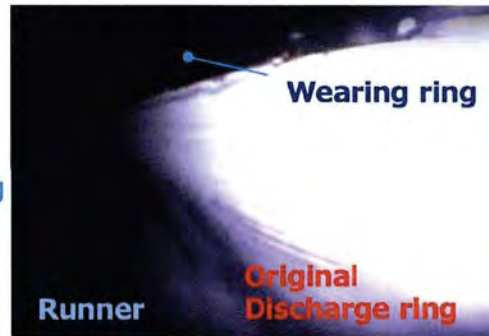
(2) Bottom of original PL

- Painting remains on the surface of the existing PL almost all around.
- No significant corrosion is confirmed even in the part where the paint is peeled off.

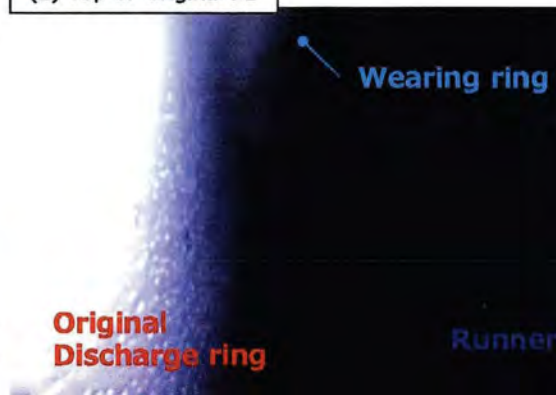
(2) Bottom of original PL

- Painting remains on the surface of the existing PL almost all around.
- No significant corrosion is confirmed even in the part where the paint is peeled off.
